The 7 Most Endangered Programme

Antioch Iron Gate \ Antakya Demir Kapi Türkiye

Technical Report

February 2026

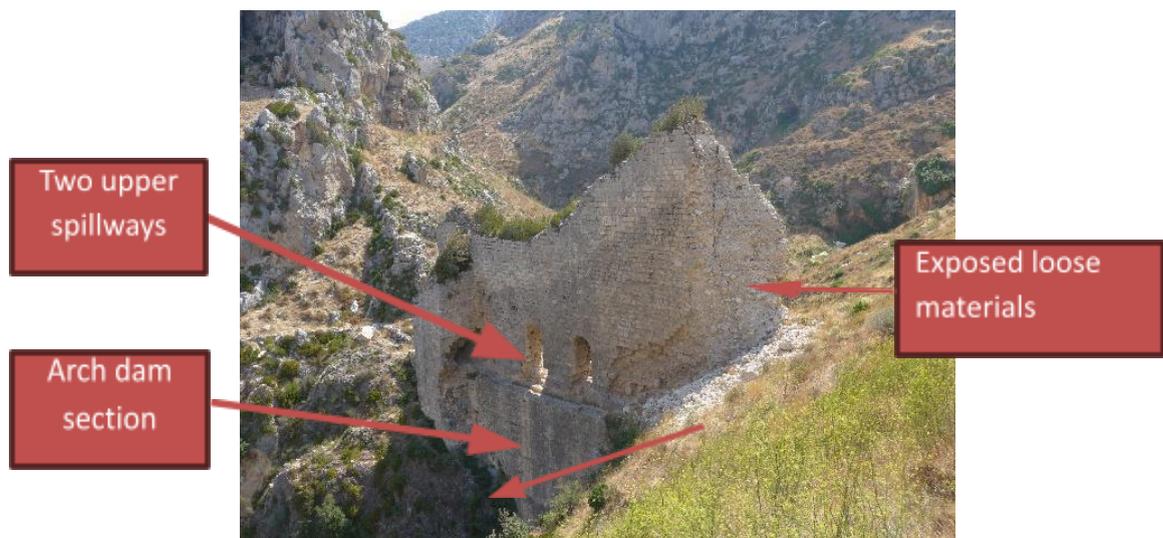
A site visit was carried out by local and Europa Nostra/EIB-Inst. experts in February 2025 and they took note of the special site and its surrounds. It was noticed that a section of the upper wall had been damaged by the February 2023 earthquake and that the general state of the structure was very poor and in urgent need of attention.

The Iron Gate from downstream 2024 (earthquake-induced mass loose material and wall collapse)

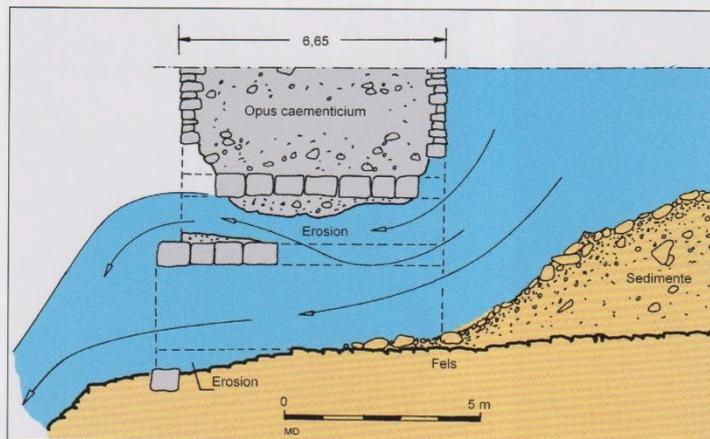
Flow conditions from 6th Century to mid 20th Century.
Progressive erosion .

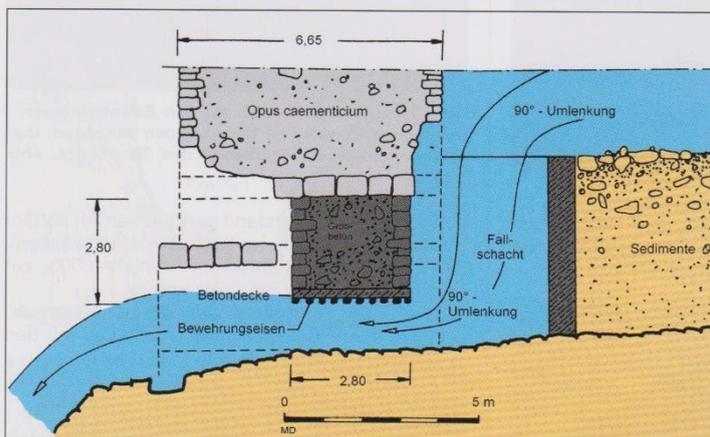
The condition and state of the bottom outlet is particularly critical as it provides the main outlet for flood flows. The condition of the structure around the orifice has clearly deteriorated over the years. It has suffered high intermittent flow rates and is composed of a masonry arch, backed by *opus caementicum* (Roman concrete). The deterioration was noted by local engineers recently and so they decided to adapt the outlet to reduce the risks by trying both to reduce the sediment and rock flows (which could block the outlet) and to repair the masonry arch outlet. The resulting works have been unhelpful. They included constructing a retaining wall several meters upstream of the outlet with the intention to retain sediment, which it no doubt has done but with other negative effects. See sketches in Appendix 3/5.

The result of these actions has been to constrain and confuse the smooth flow conditions of the outlet and to significantly reduce its capacity from an estimated 45 m³/sec to 19 m³/sec. The finer sediment retained could have probably been safely passed through the outlet anyway and the more important larger blocks, if they were to be a problem, should have been retained much higher up in the stream and not close to the outlet. The new flow through the bottom outlet after these changes would be much more turbulent as the water must pass through two right angle turns just upstream of the outlet. This turbulent flow would have increased its erosive potential and the damage to the bottom outlet which is now very evident and serious.

Flow conditions late 20th Century.
Sediment retaining wall and concrete repairs to masonry arch.

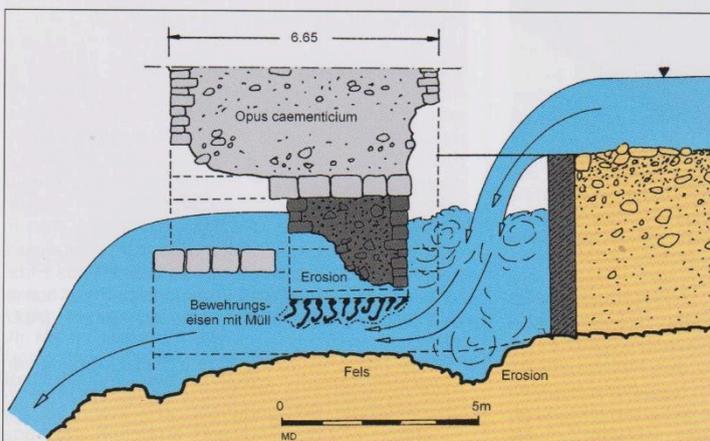
These repairs were intended to rebuild the arch of the bottom outlet using reinforced concrete to protect the structure. Unfortunately, with the high flow velocities (estimated at 11 m/sec) and the increased turbulence, as explained above, the concrete layer has largely broken-down, leaving steel reinforcement bars which have trapped various floating matter and plastics to further reduce the efficiency of the outlet. It is unclear how well the added concrete was bonded into the existing dam structure as this is essential for long-term stability.

Flow conditions in 2008.
Unsatisfactory flows have eroded much of the concrete repairs. Maybe further erosion since.

In general, the sediment retaining wall needs to be removed to improve the flow conditions upstream of the outlet and the outlet needs to be properly repaired so that the flow passes smoothly. Any concrete skin needs to be firmly connected into the existing dam structure. This work needs to be coordinated with other work on the structure as covered elsewhere. Ideally a rock trap may need to be installed further upstream of the dam to prevent potential blockage of the outlet.
