# The 7 Most Endangered 2024

## **St. Georgios Church** **Altınözü, Hatay province, Türkiye**

### **Technical Report**

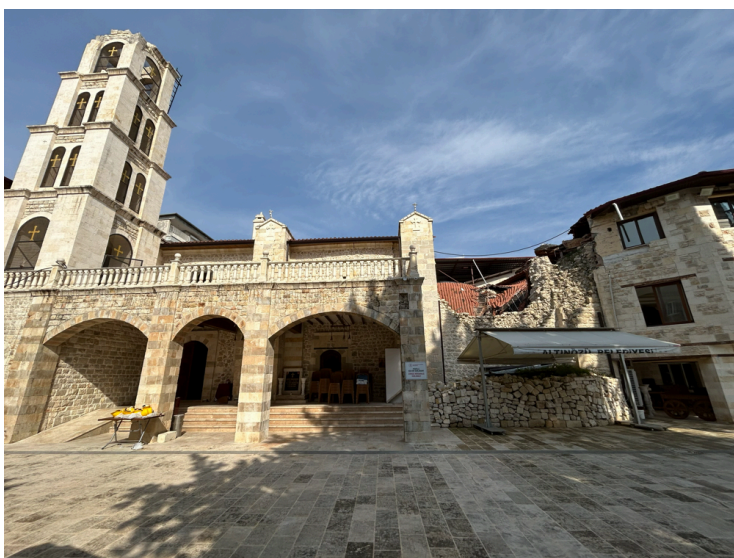
*Fig. 1: South elevation with damaged wall*

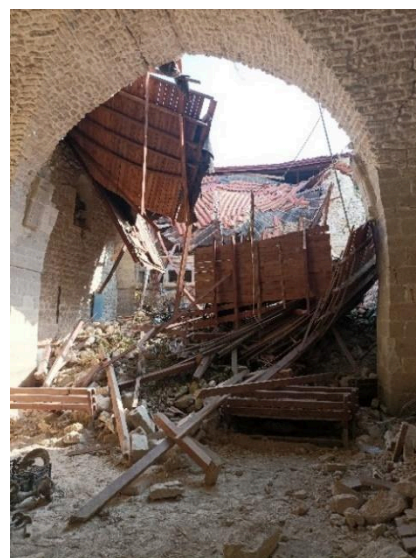
On February 6, 2023, the devastating earthquake in the Hatay province area caused the collapse of the church's central vault, the adjacent north and south masonry walls, and most parts of the wooden roof including the apse area. Additionally, several damages, particularly cracks and fallen pieces, are visible in other elements, such as the front portico, the bell tower, and the remaining vaults.

*Fig. 2: Interior roof collapse*

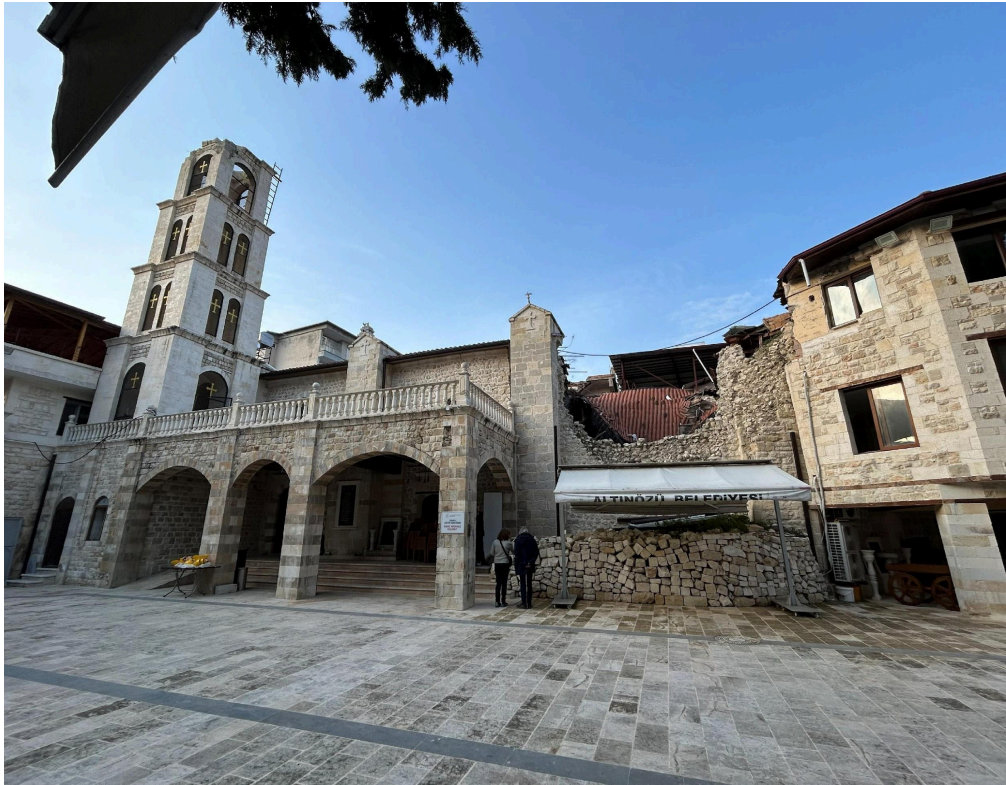
*Fig. 4: External view of Saint Georgios Church,  
showing the destruction caused by the earthquake on the south wall and belltower*

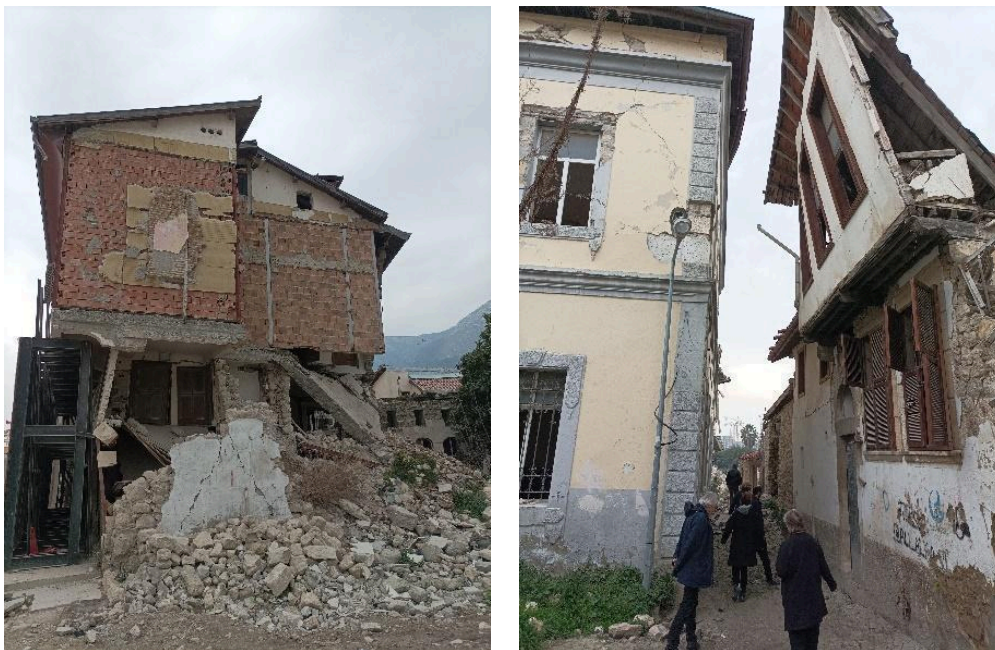
*Fig. 5,6: Damaged buildings from the 2023 earthquake in Antioch city center*

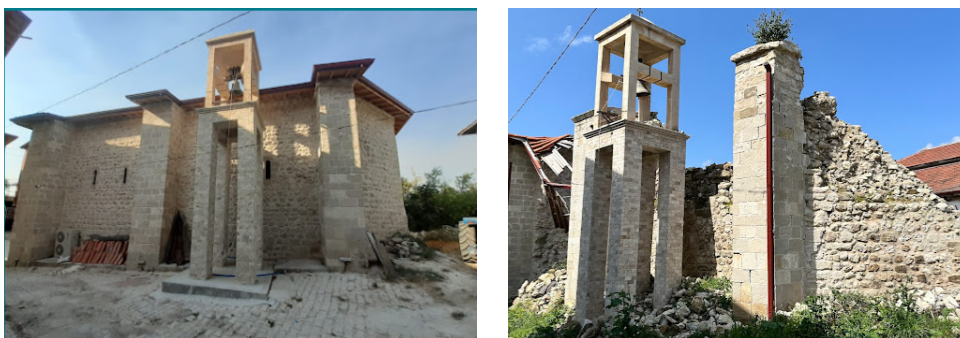
The church's architectural design bears a striking resemblance to Meryem Ana Rum Kilisesi in the neighbouring village of Tokaçlı, situated 3 km away (location: 36.101794, 36.260644). This similarity can potentially provide clues of inaccessible areas of the church, and insights on seismic behavior, as they share a comparable morphological structure.

Fig. 7, 8: Tokaçlı church, before and after the earthquake (images: Google Maps)

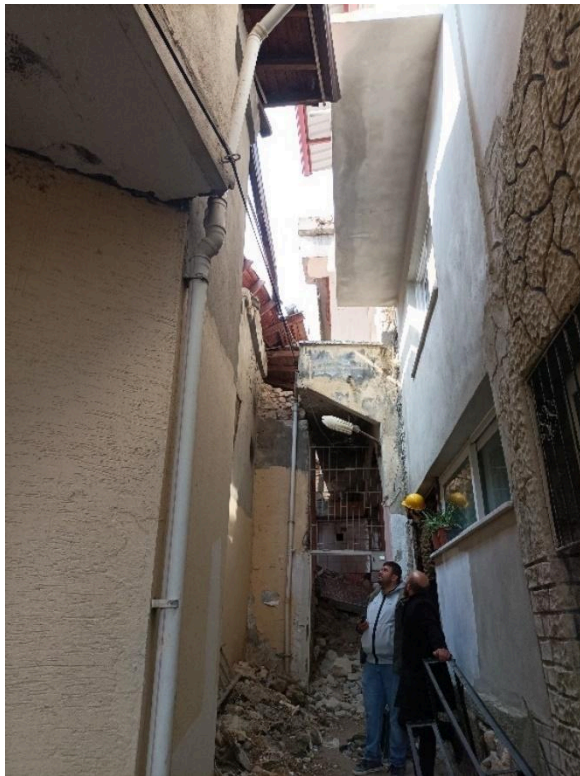
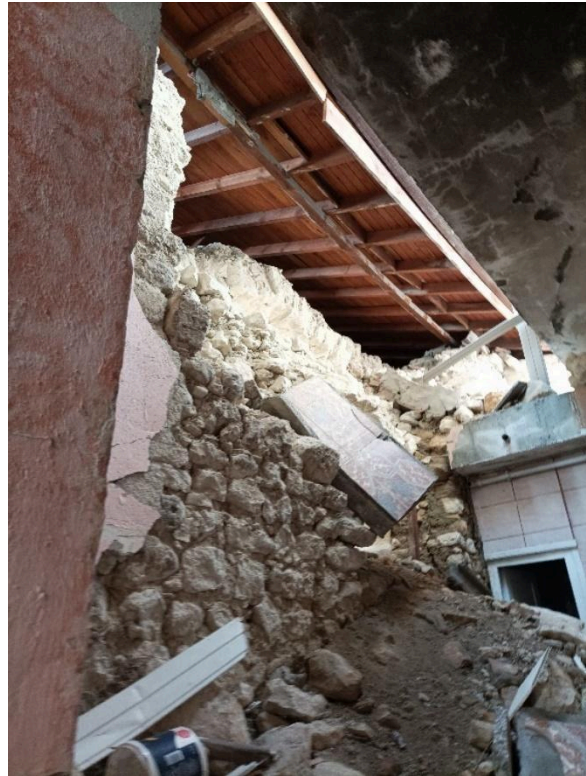
Comparable uncertainties are present on the north and west sides of the church. It is worth noting that these areas, likely stabilised by the additions, remained standing. However, this also implies a lack of certainty about the actual condition of these sections and the internal composition of the walls. In contrast, the sister church of Tokaçlı, which lacked any adjoining structures, suffered a complete collapse.

*Fig. 9, 10: Northern part of the church with attached constructions / houses.*

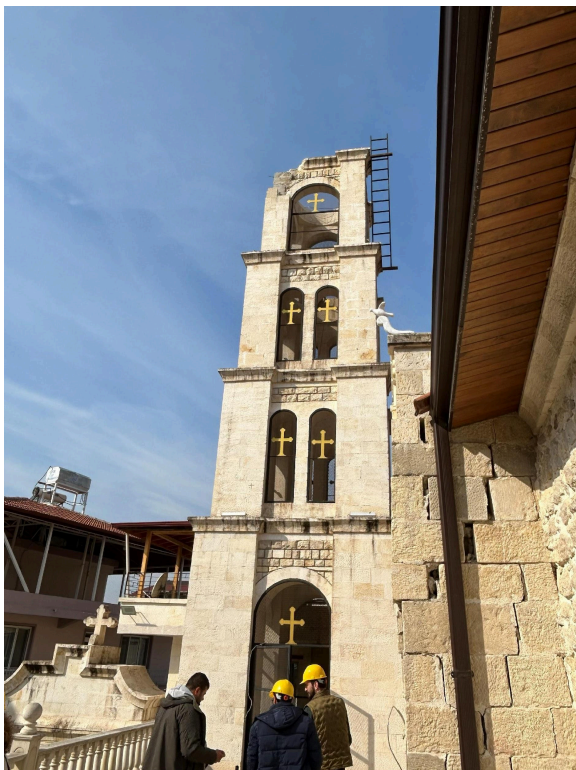
*Fig. 11: Belltower*

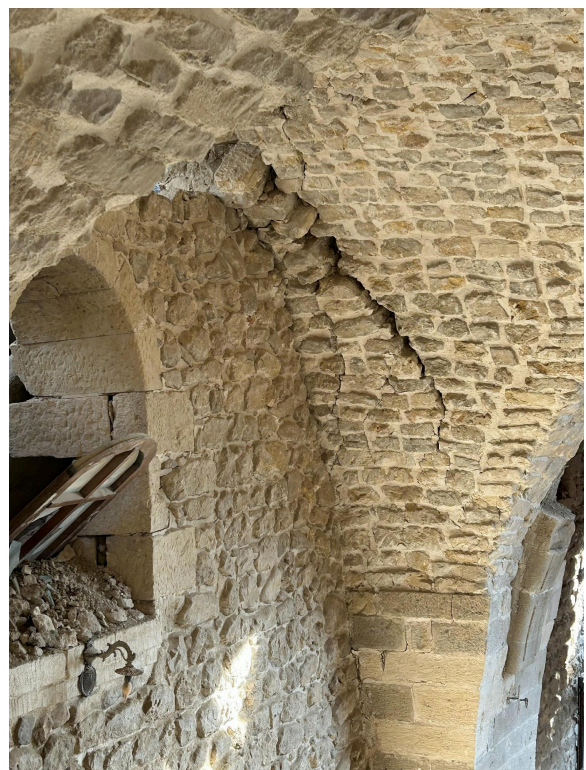
*Fig. 12: Cracks on the northern wall*

- **Routine structural inspections** (non-monitored areas): implement a schedule for periodical visual inspections of existing structures. This is crucial for early identification of potential problems (e.g., cracks, dampness/humidity issues, structural faults) in areas where continuous electronic monitoring is not feasible due to economic or other constraints.

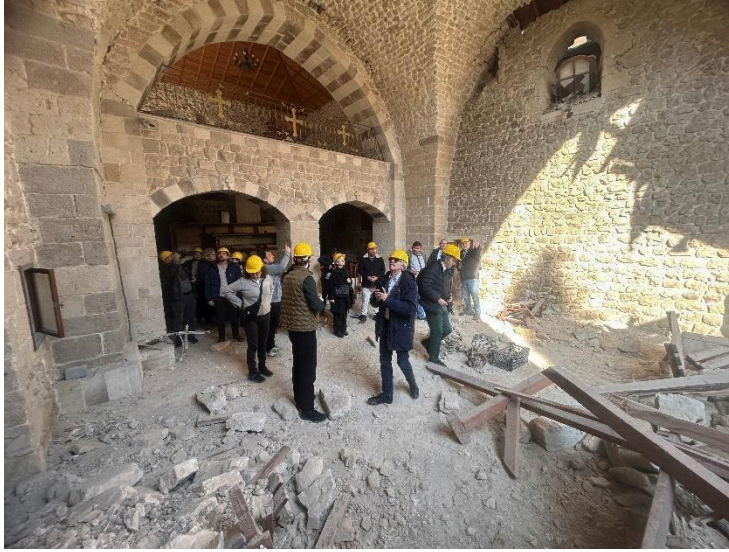
Fig. 13: Interior looking north east towards the gynaeceum

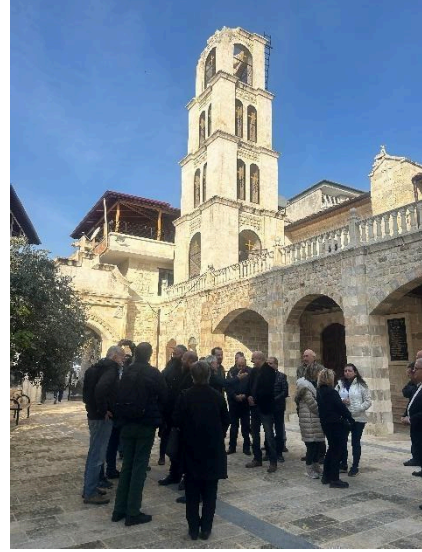
Fig. 14: South view, courtyard

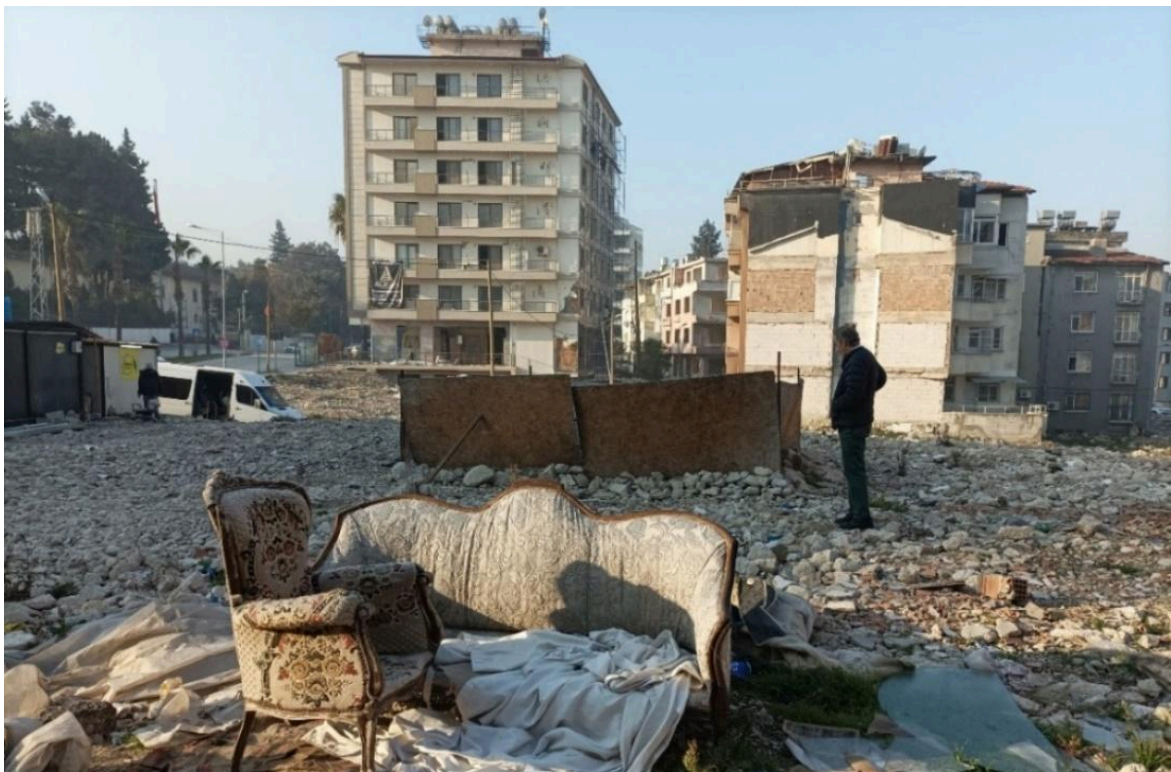
*Fig. 19: Antioch. Photo shows a demolished building after the earthquake damage. On the back, buildings are damaged but still standing.*

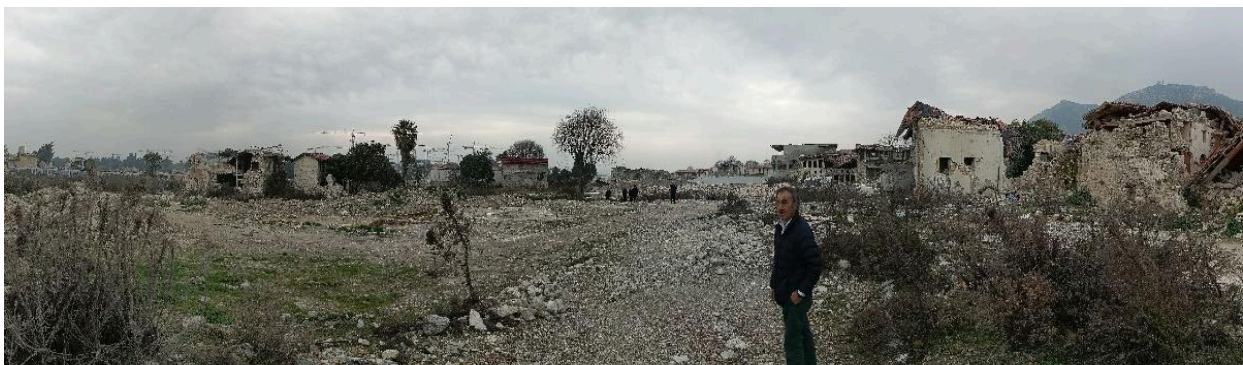
*Crucially, the entire river valley area, up to 133 meters of archaeological and sedimentary layers—was the most severely affected zone of the city.*

*Fig. 24: General view of the center of Antioch after the earthquake destruction*
