The 7 Most Endangered Programme

Antioch Iron Gate \ Antakya Demir Kapi Türkiye

Technical Report

February 2026

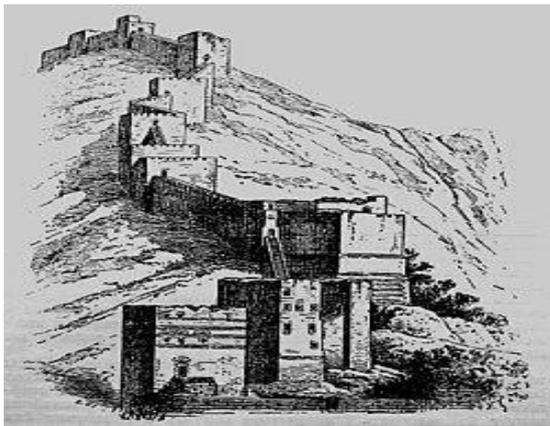
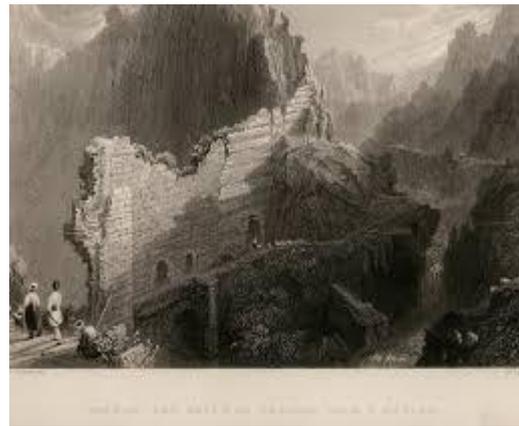
The ramparts of Antioch climbing Mons Silpius during the Crusades and at right the Iron Gate at the end of XIX century (J. Carne, “Syria, The Holy Land, Asia Minor (1836–38)”)
